Manhole Inspection Summary

Manhole # S21II1002MH

Location Address: **4305 LAPLATA AVE**

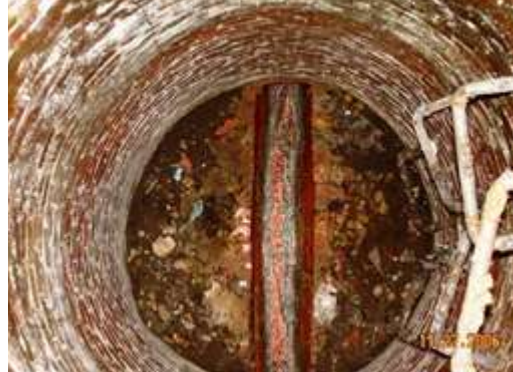
Top View

Evidence of surcharge - Bench debris.

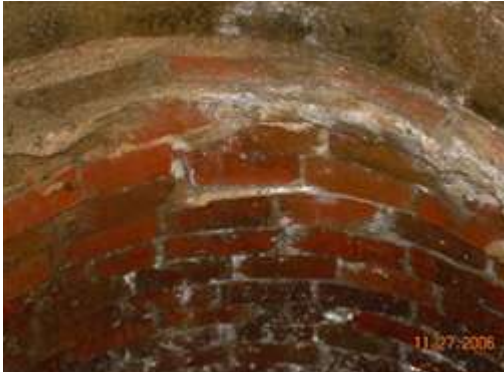
Defect

Frame leaks. Adjustment deterioration and infiltration. Corbel infiltration.

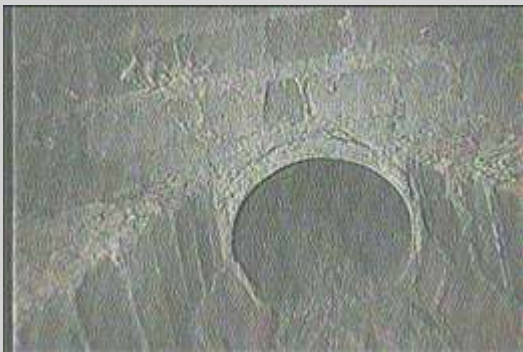
8 in. Circular Gravity Sewer Pipe Out @ 12 O'Clock

Infiltration: **Evidence** Pipe Seal Cond: **Cracked**

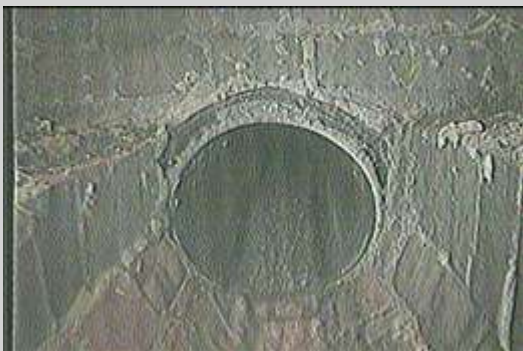
8 in. Circular Gravity Sewer Pipe In @ 6 O'Clock

Infiltration: **Evidence** Pipe Seal Cond: **Unknown**
